# A Sound Home Inspection

Page 1 of 18  
sample.inspx

## General Information

Property Address 123 Any St  
City Yourtown State NY Zip 10000  
Contact Name My Realtor  
Phone (555)555-5550  
Fax (555)555-5552

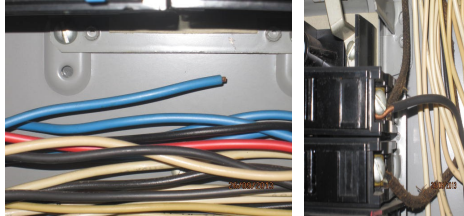
Breakers: Copper Double taps are present at breakers. These circuits need to be moved to their own circuit breaker and cannot share a breaker. It is recommended that a qualified electrician inspect the new circuits and properly connect the new circuits to an individual breaker for each circuit
