# *A Sound Home Inspection, LLC*

## Property Inspection Report

123 Your New Street, New City, NY 11101  
Inspection prepared for: Sam Pell  
Date of Inspection: 4/23/2015

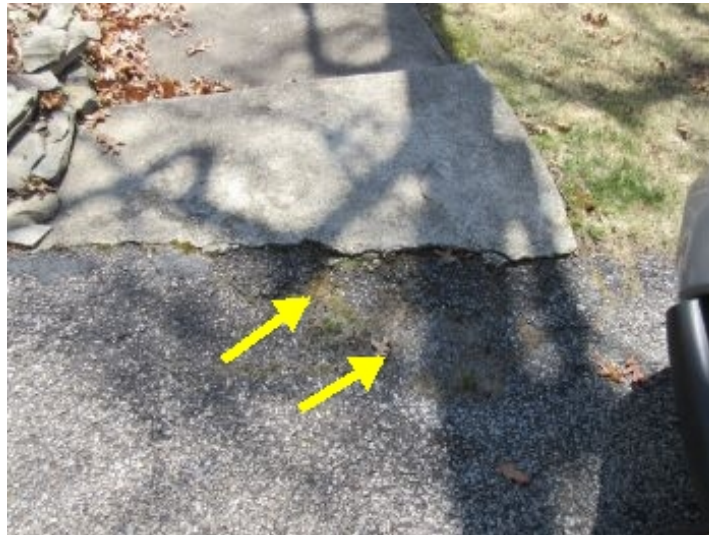
- This stairway had moderate surface deterioration (C).

Uneven walking surface

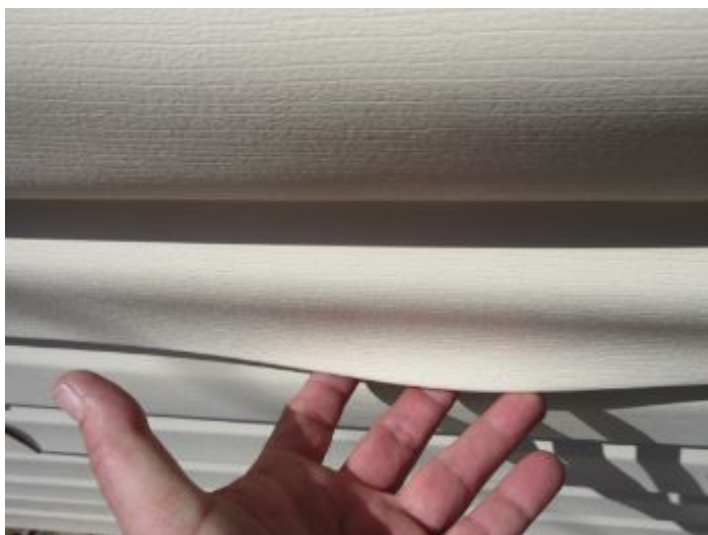
House Exterior Finish: • Vinyl Siding • Condition - Mostly acceptable- see photo  
Window and Door Trim ; • Aluminum • Condition - Acceptable at the time of the inspection  
• The siding covering exterior walls had areas of minor damage, which should be repaired to prevent moisture intrusion of the wall assembly.

Damaged siding

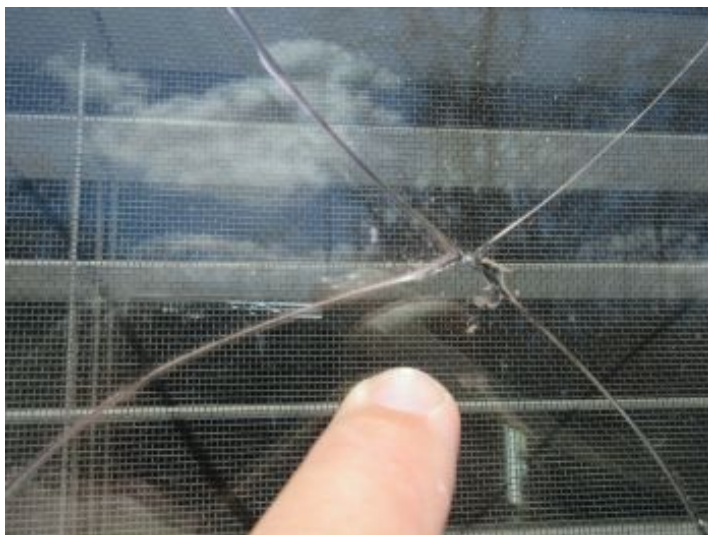
- Windows Exterior - Mostly acceptable- see note
- There were window screens missing from several locations on the structure. Ask the current owner if the screen frames can be located.
- There was broken glass on the first floor, right side of the house

Broken glass

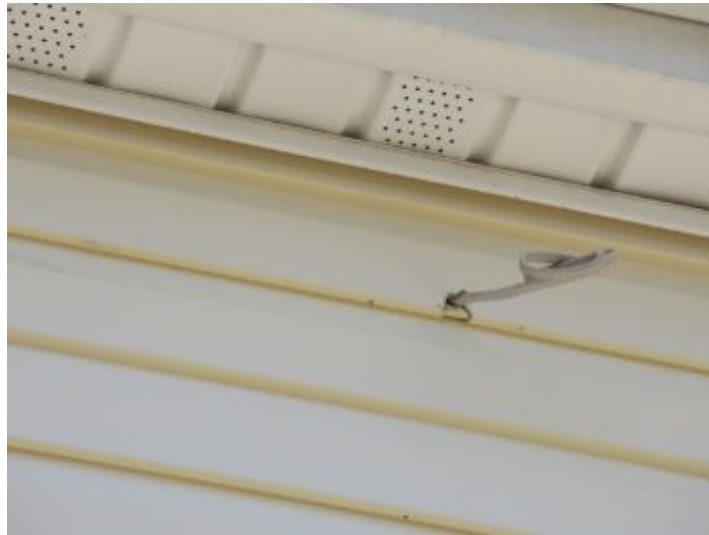
- Light #2 : Light fixtures mounted on the exterior of the house were missing and needed reinstallation . Some light fixtures had energized electrical components exposed to touch. This condition is a shock/electrocution hazard .

Missing light fixture

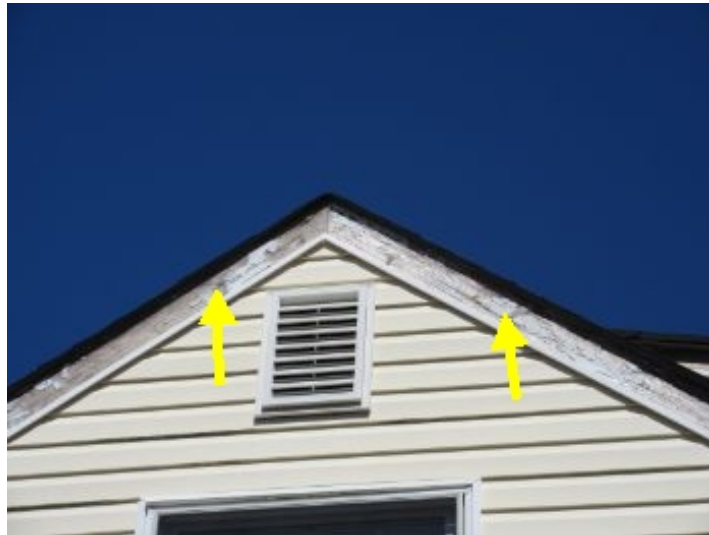
• The fascia on the eaves of the house were exhibiting signs of moderate deterioration due to deferred maintenance. Painting or covering the fascia with an appropriate material will prolong the life of the fascia.

Roof Eaves

Recommendation: Have a qualified contractor perform any necessary repair to the fascia boards on the eaves.

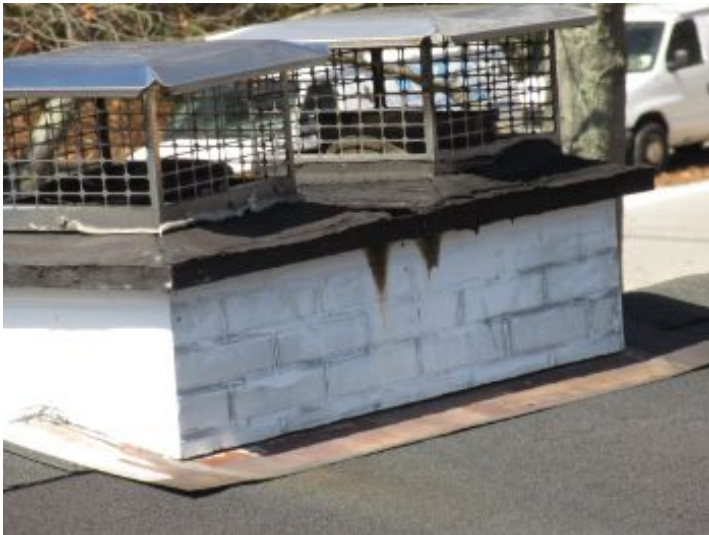
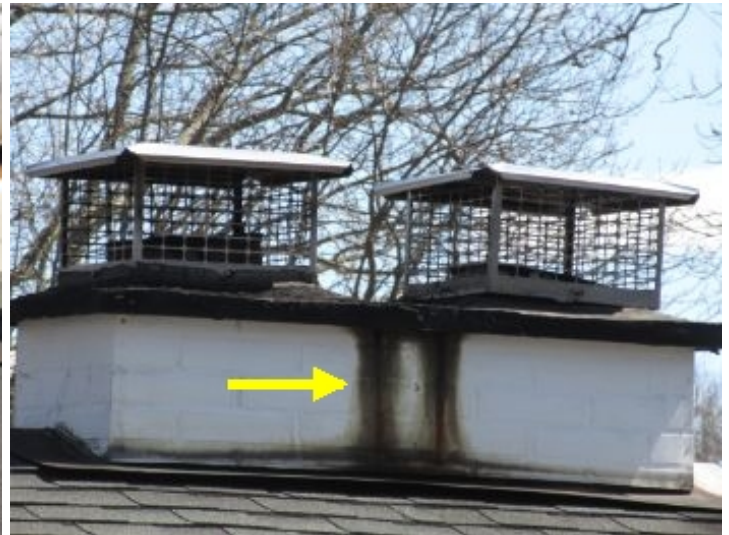
- Condition - Damage - see note
- Rust and corrosion at top exterior chimney flue pipe at roof. Repair as needed.

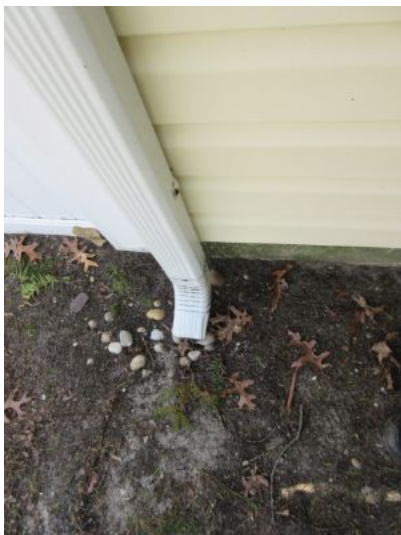
- FYI - Extensions / Splash blocks were missing or insufficient, installing extensions/splash blocks will assist in diverting water away from the foundation.

Install splash blocks

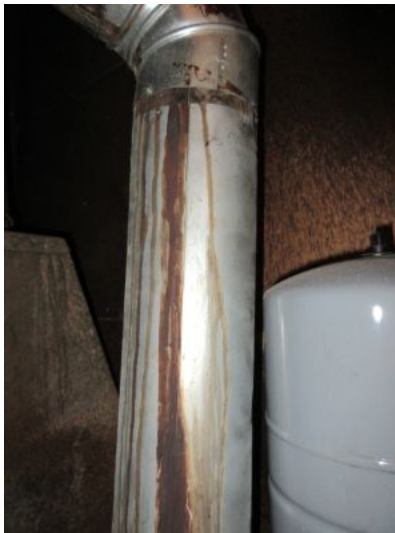
- Condition - Mostly acceptable- see note
- Corrosion visible at the base of the heating system exhaust flue indicated the presence of excessive amounts of moisture, typically related to condensation formed by improper exhaust flue conditions.

This condition may result in premature failure of furnace components.

Boiler Flue Pipe

Recommendation: You should have a qualified HVAC contractor evaluate and perform any necessary corrections or repairs to heating system to ensure safe and efficient operating conditions exist. (SEE **COMBUSTION AIR** NOTE)

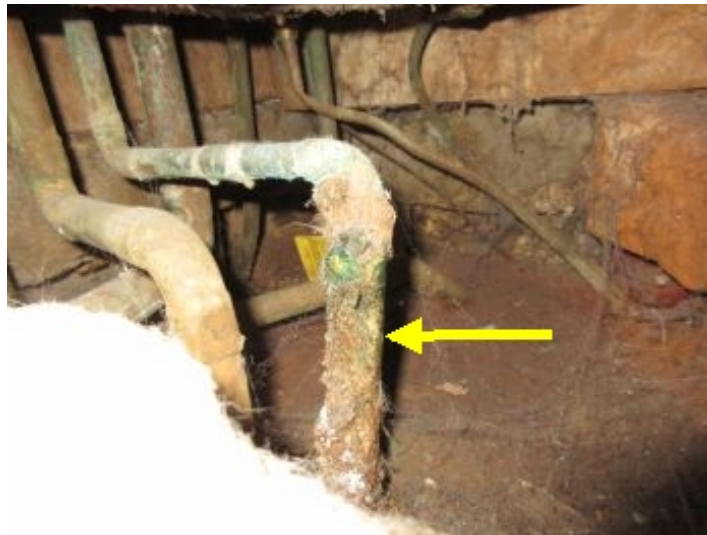
- There was a pipe under the boiler burner that was exhibiting signs of moderate/severe deterioration and oxidation.
- Recommendation have a qualified plumber provide you with cost estimates for any necessary repairs to the water supply and/or heating system pipe located under the boiler burner assembly.

Pipe deterioration

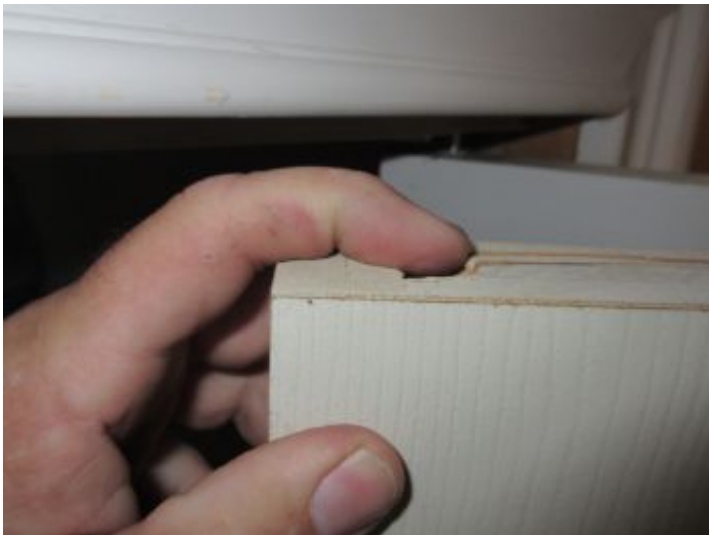
- The door to this room was missing the top guide pin and was cracked.

Missing post

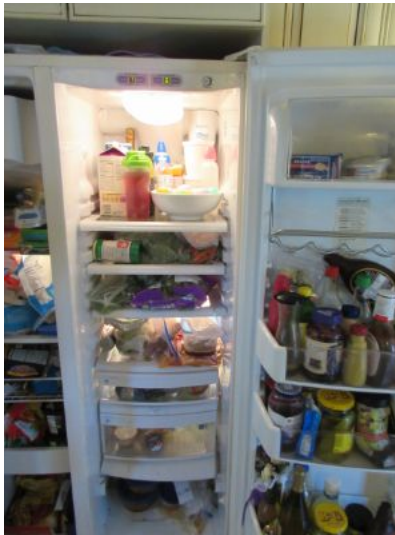
- The refrigerator had missing drawers.

Refrigerator

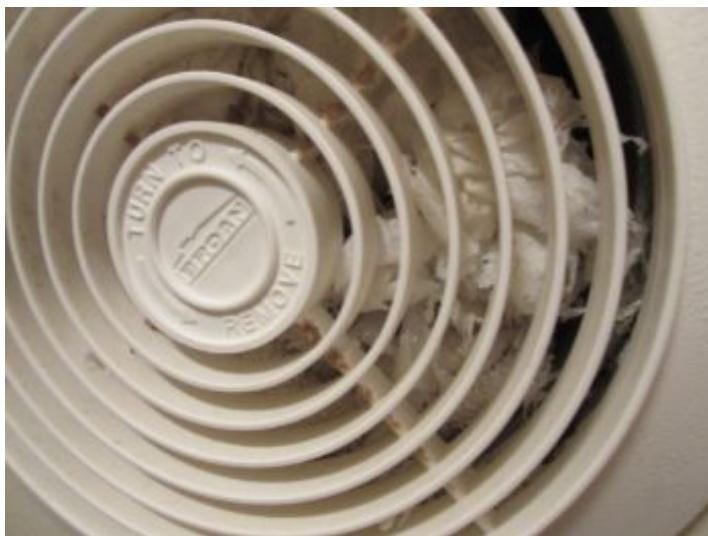
- #2 : The bathroom exhaust fan appeared to be inoperable at the time of the inspection.

Bathroom #2 fan

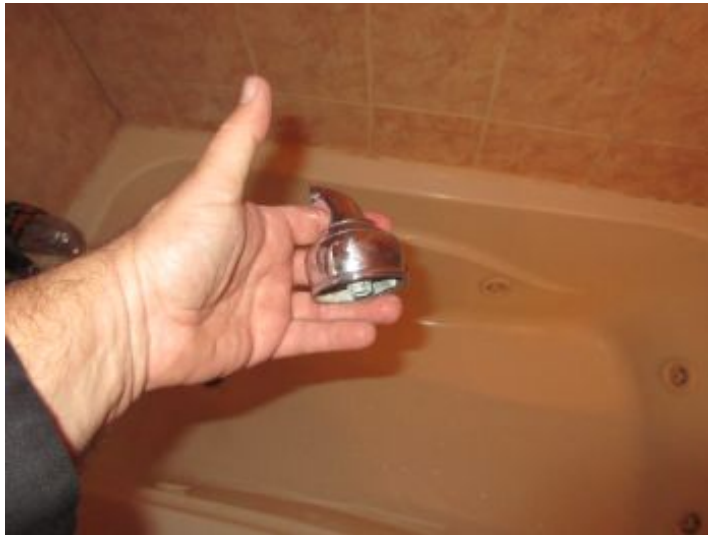
• The tub/ shower faucet had a broken handle.

Bathroom #2 Tub faucet handle

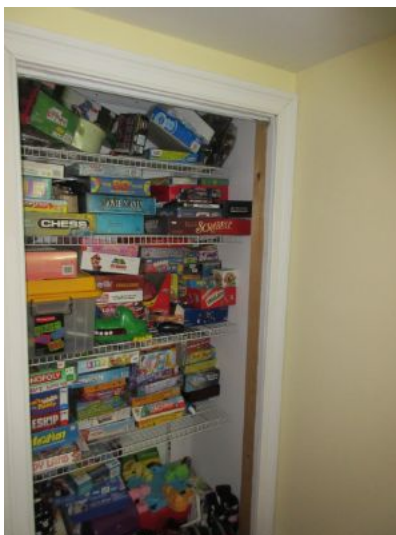
Room # 5

- Room #5 : The closet door in this room was missing.

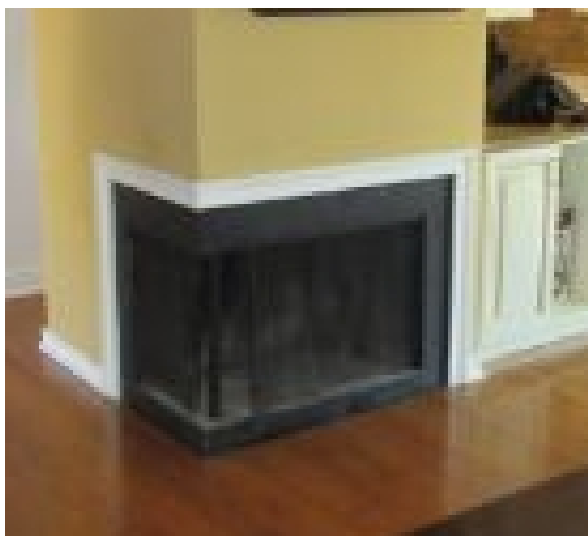
- There was no hearth installed at the fireplace. A non flammable hearth should be installed at the fireplace to prevent hot ashes from falling onto and igniting the wood floor.

No Hearth

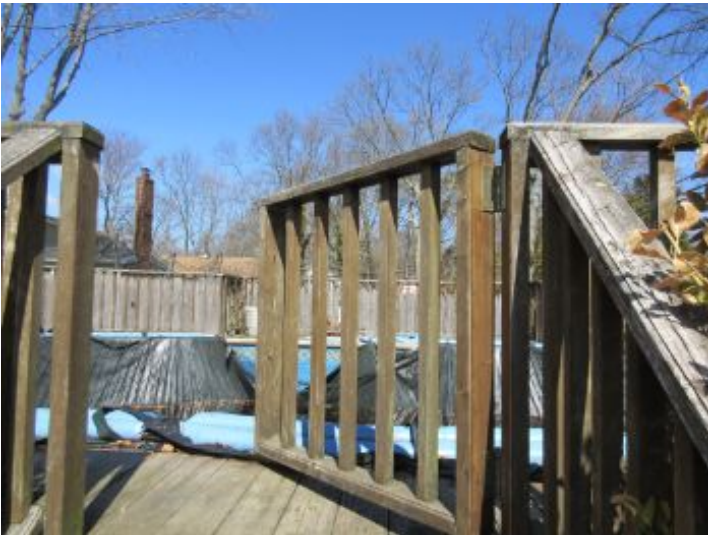
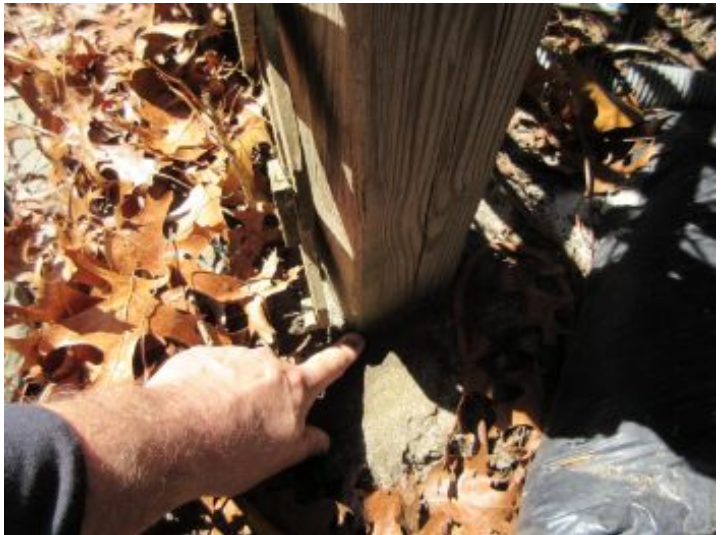
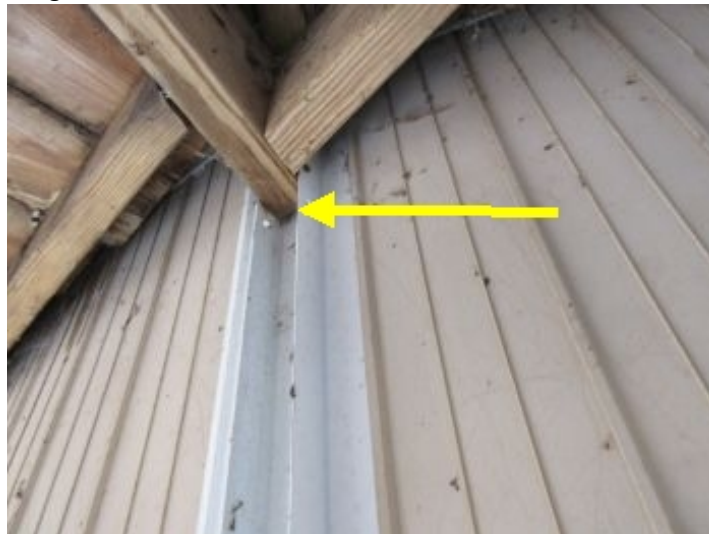
- **The deck was relaying on the pool wall braces and pool edge for support. To avoid potential deck and pool collapse addition footing and deck posts should be installed for added deck support.**
- **The gate at the pool deck should be self closing and alarmed for safety reasons**

Pool deck gate

Post and footing

Addition support needed

- RECOMMENDATION:** You should have a qualified contractor evaluate and perform any necessary repairs or replacement to effected deck components.

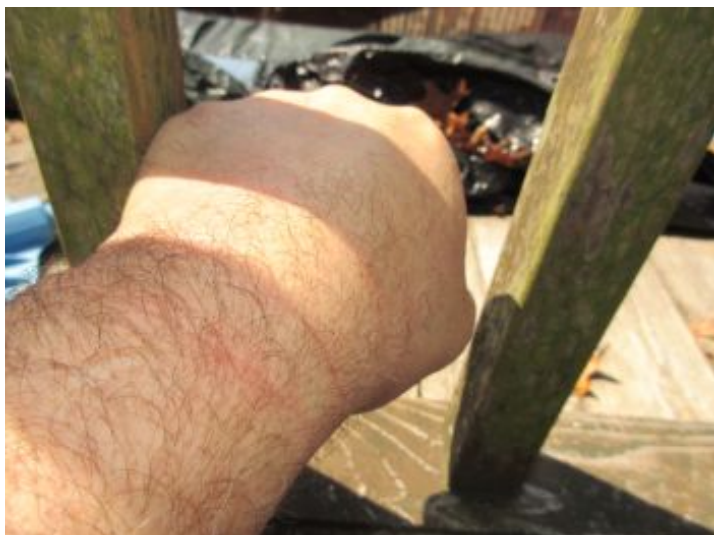
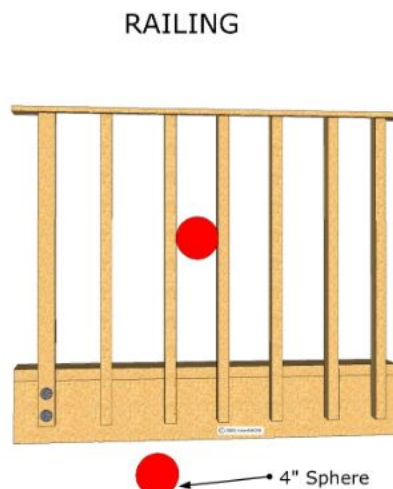
- The gate did not self latch or alarmed.

Pool balluster spacing

Balluster Spacing

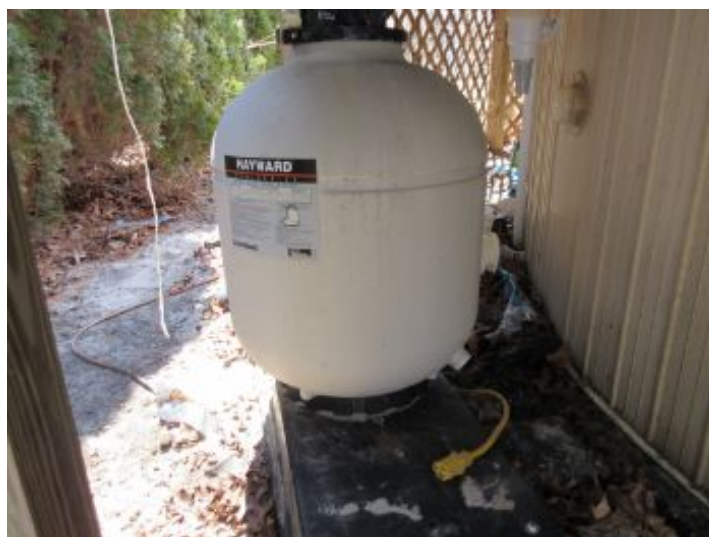
- The pool filter electric was supplied with Extension cords.  
Recommendation: have a qualified licensed electrician install permanent **GFCI** protected electric supply to the pool filter.

Extension cord

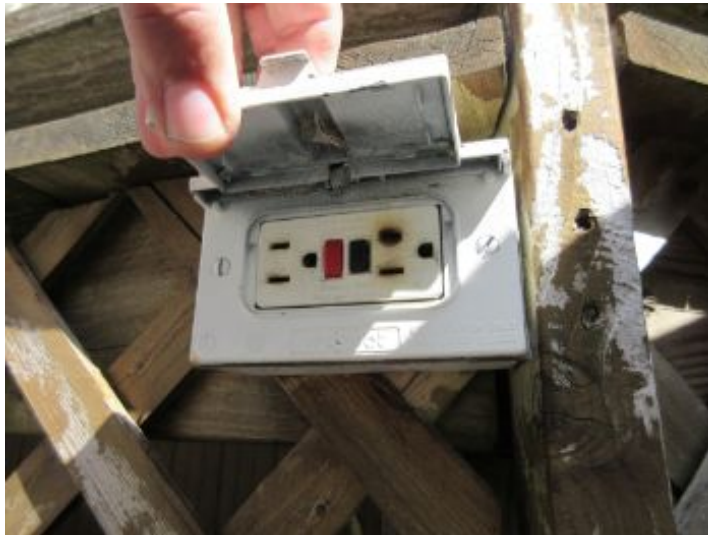
- The **GFCI** **receptacle** at the pool exhibited signs of a short circuit. This **receptacle** should be protected with an all weather cover to prevent electric shock hazard.

Damaged pool side GFCI
