A Sound Home Inspection, LLC

Property Inspection Report

123 Your New Street, New City, NY 11101
Inspection prepared for: Sam Pell
Date of Inspection: 4/23/2015

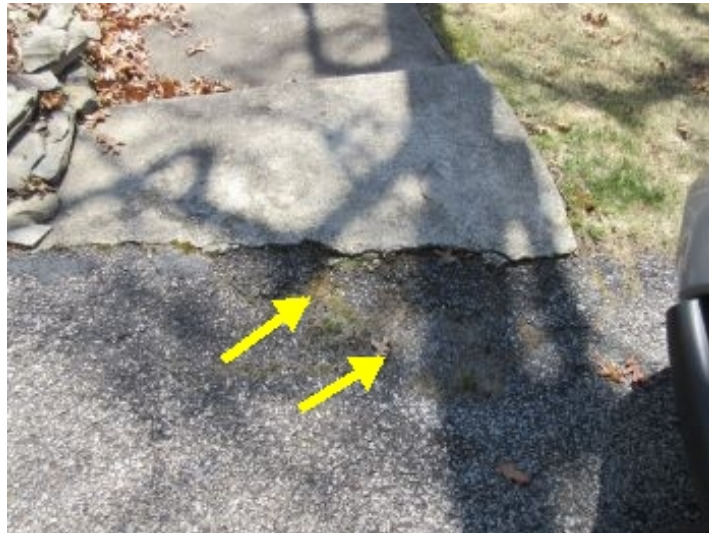
- This stairway had moderate surface deterioration (C).

Uneven walking surface

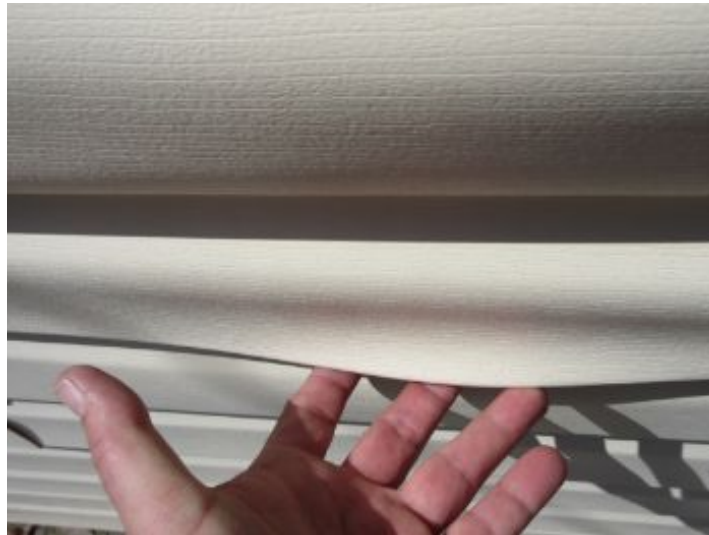
- House Exterior Finish: • Vinyl Siding • • Condition - Mostly acceptable- see photo
Window and Door Trim ; • Aluminum • • Condition - Acceptable at the time of the inspection
- The siding covering exterior walls had areas of minor damage, which should be repaired to prevent moisture intrusion of the wall assembly.

Damaged siding

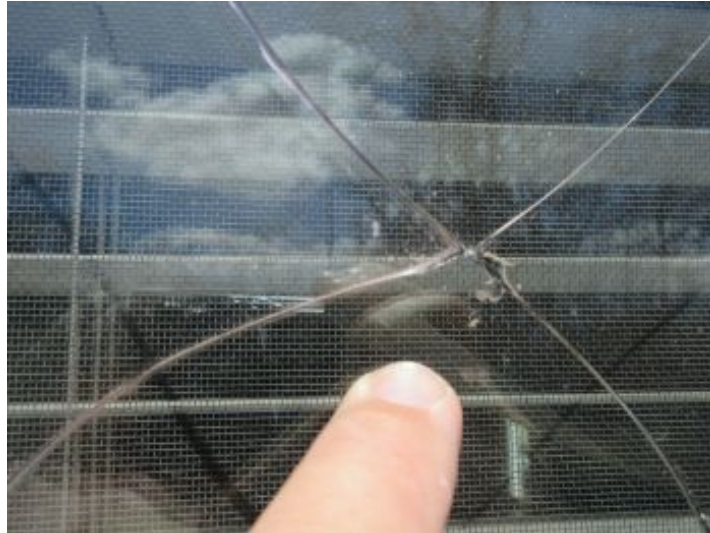
- Windows Exterior - Mostly acceptable- see note
- There were window screens missing from several locations on the structure. Ask the current owner if the screen frames can be located.
- There was broken glass on the first floor, right side of the house

Broken glass

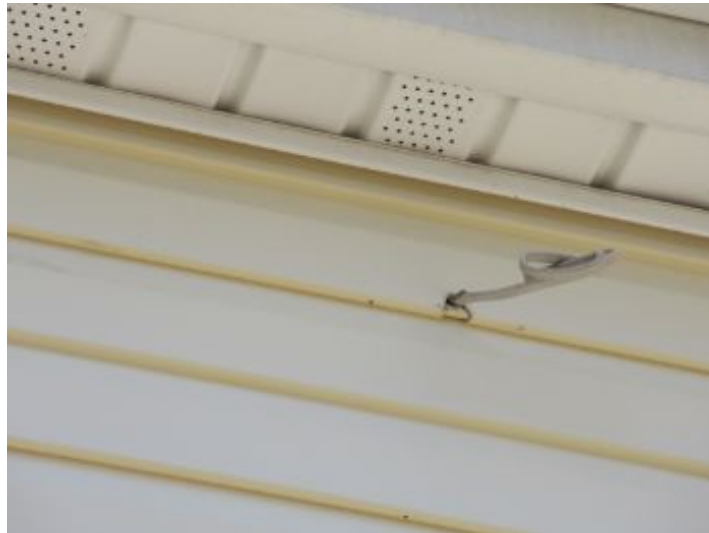
- Light #2 : Light fixtures mounted on the exterior of the house were missing and needed reinstallation . Some light fixtures had energized electrical components exposed to touch.

This condition is a shock/electrocution hazard .

Missing light fixture

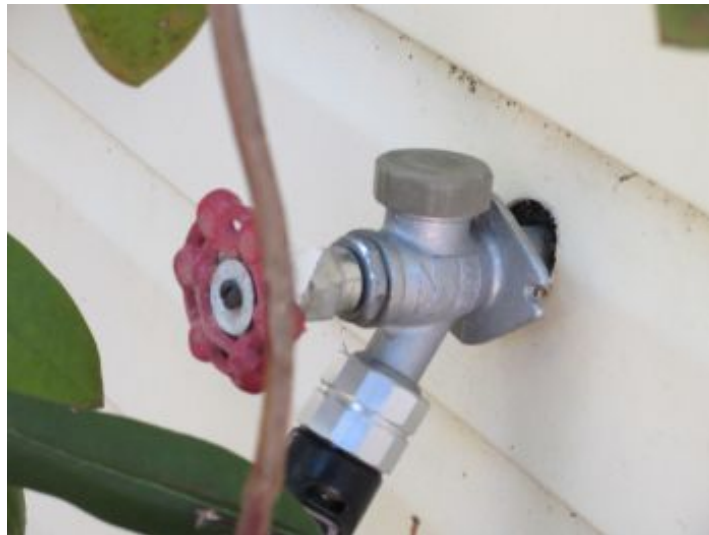
• Hose Bib #2 ; The water hose bibs was not frost proof and will need to be winterized before weather turns below 32° as pipe damage can occur.

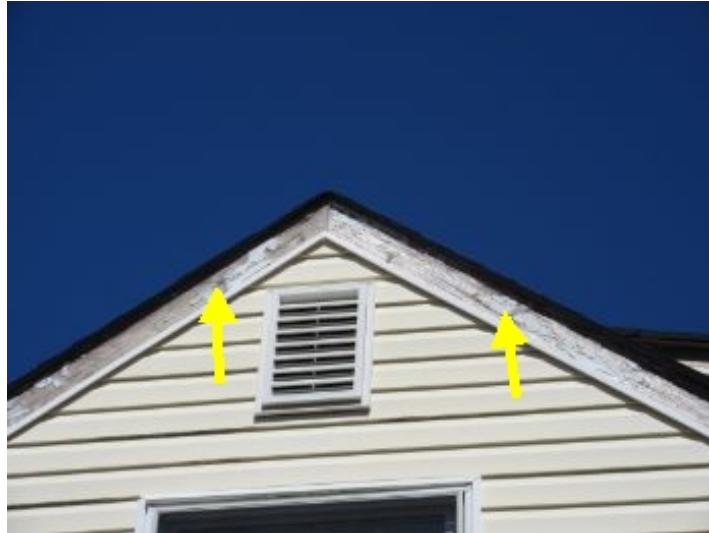
• The fascia on the eaves of the house were exhibiting signs of moderate deterioration due to deferred maintenance. Painting or covering the fascia with an appropriate material will prolong the life of the fascia.

Roof Eaves

Recommendation: Have a qualified contractor perform any necessary repair to the fascia boards on the eaves.

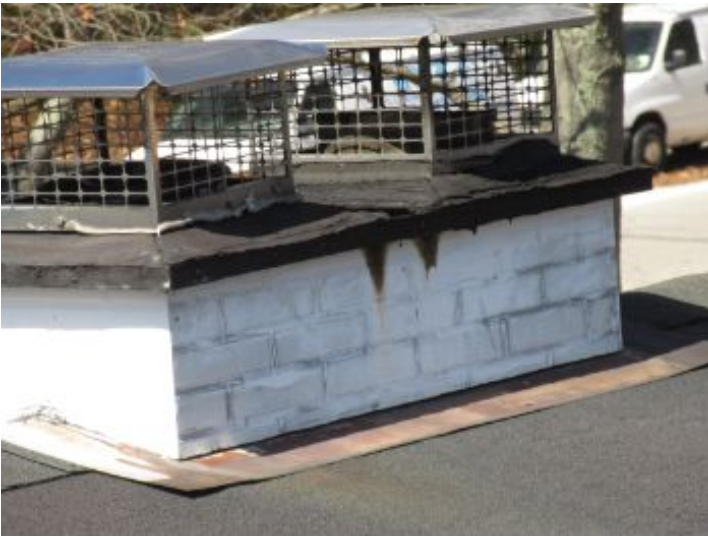
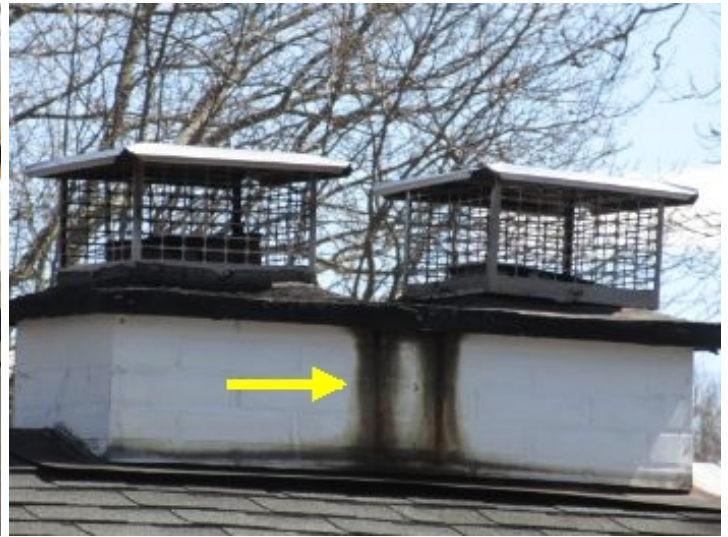
- Condition - Damage - see note
- Rust and corrosion at top exterior chimney flue pipe at roof. Repair as needed.

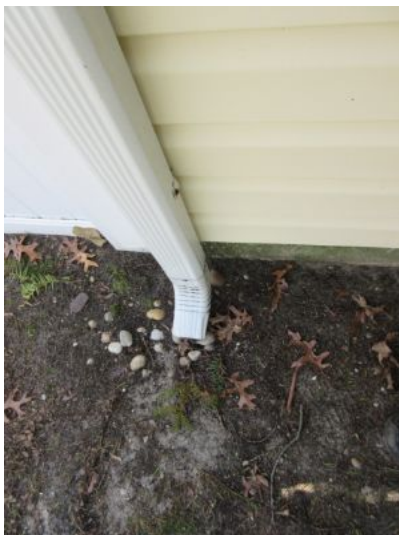
- FYI - Extensions / Splash blocks were missing or insufficient, installing extensions/splash blocks will assist in diverting water away from the foundation.

Install splash blocks

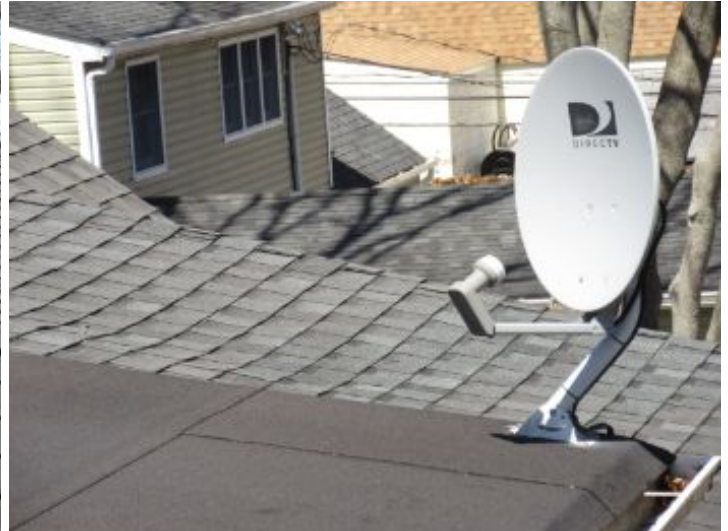
- **Satellite dishes that penetrate the roof should be monitored to ensure that they are securely attached to the roof and that the attachment points are sealed with an appropriate sealant.**

Satellite Dish

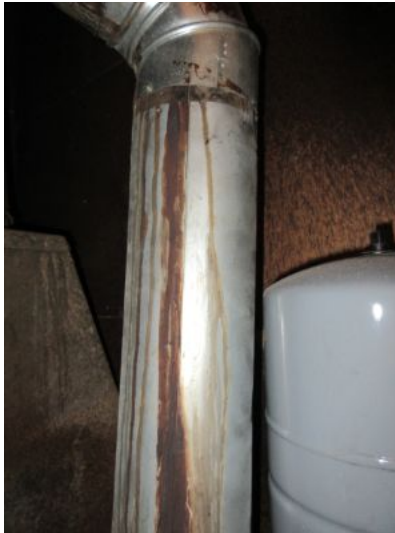
- Condition - Mostly acceptable- see note
- Corrosion visible at the base of the heating system exhaust flue indicated the presence of excessive amounts of moisture, typically related to condensation formed by improper exhaust flue conditions.

This condition may result in premature failure of furnace components.

Boiler Flue Pipe

Recommendation: You should have a qualified HVAC contractor evaluate and perform any necessary corrections or repairs to heating system to ensure safe and efficient operating conditions exist. (SEE **COMBUSTION AIR** NOTE)

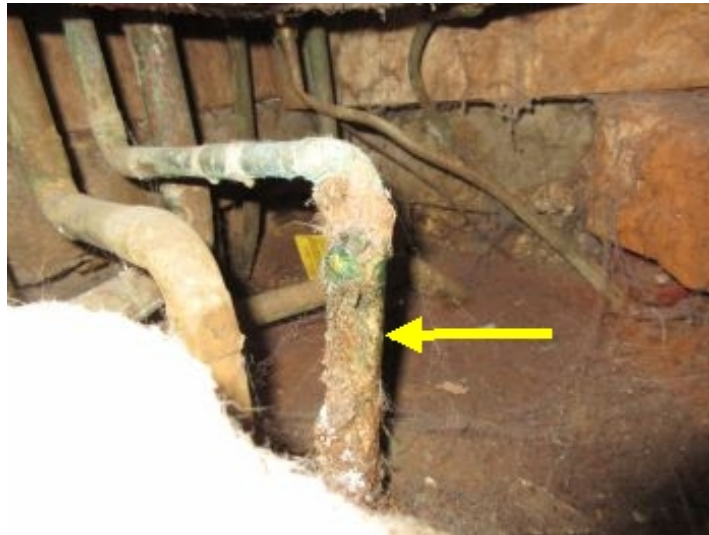
- There was a pipe under the boiler burner that was exhibiting signs of moderate/severe deterioration and oxidation. Recommendation have a qualified plumber provide you with cost estimates for any necessary repairs to the water supply and/or heating system pipe located under the boiler burner assembly.

Pipe deterioration

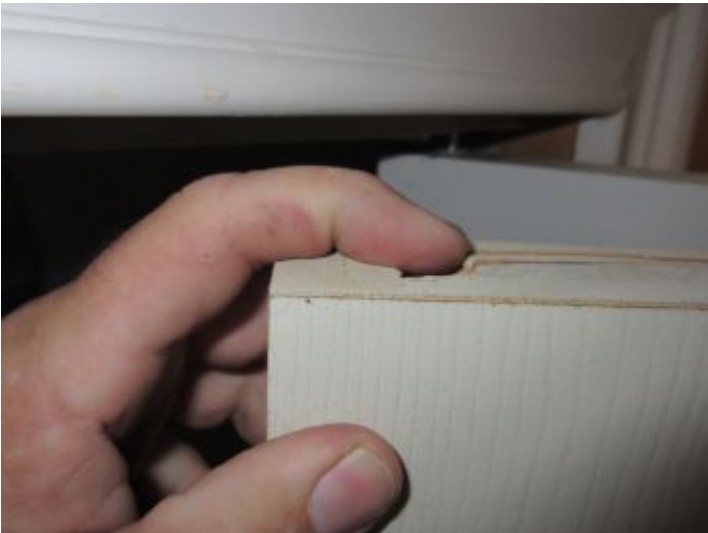
- The door to this room was missing the top guide pin and was cracked.

Missing post

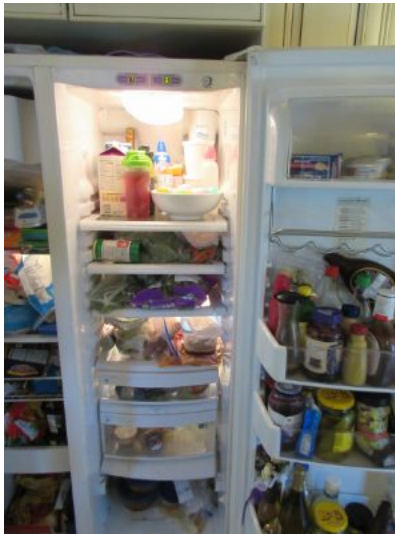
- The refrigerator had missing drawers.

Refrigerator

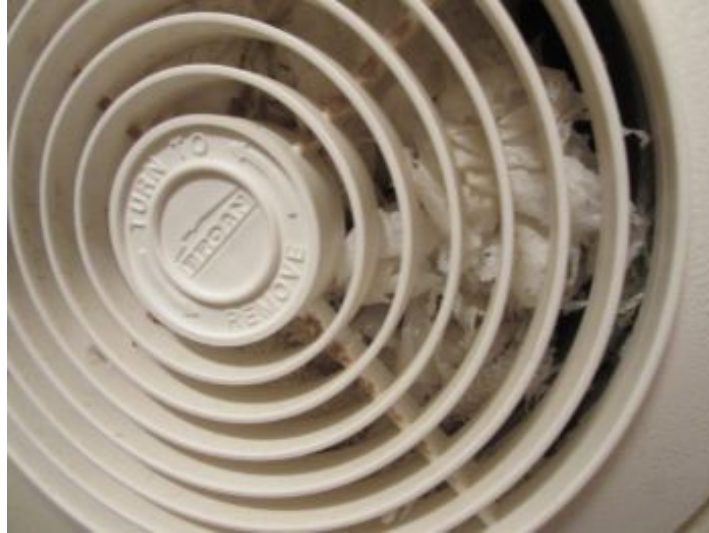
- #2 : The bathroom exhaust fan appeared to be inoperable at the time of the inspection.

Bathroom #2 fan

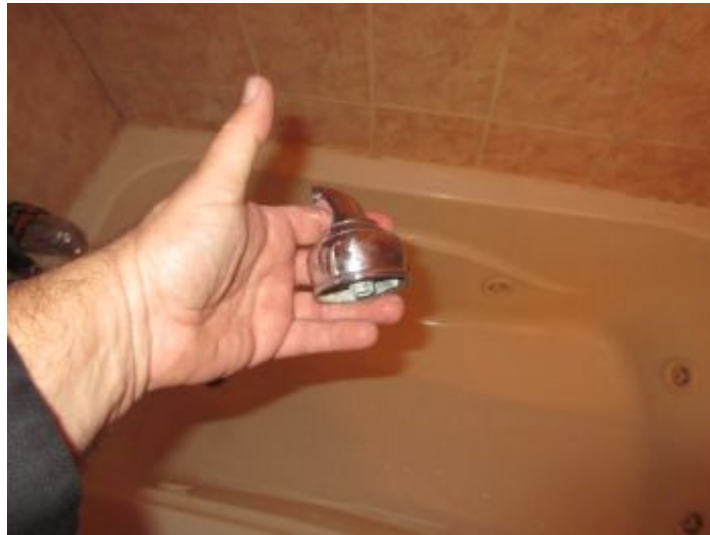
- Condition - Damage - see note
- The tub/ shower faucet had a broken handle.

Bathroom #2 Tub faucet handle

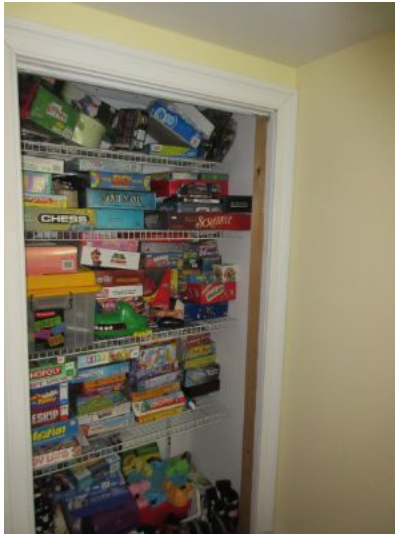
Room # 5

- [Mostly OK] Most of the closets throughout the house appeared to be in acceptable condition, notable exceptions have been identified.
- Room #5 : The closet door in this room was missing.

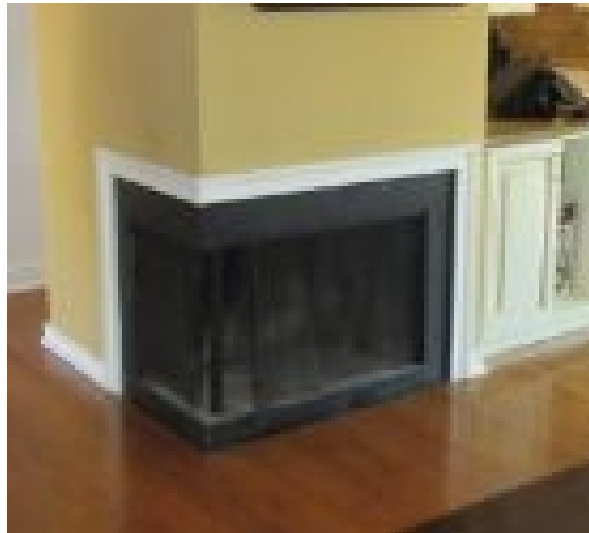
• There was no hearth installed at the fireplace. A non flammable hearth should be installed at the fireplace to prevent hot ashes from falling onto and igniting the wood floor.

No Hearth

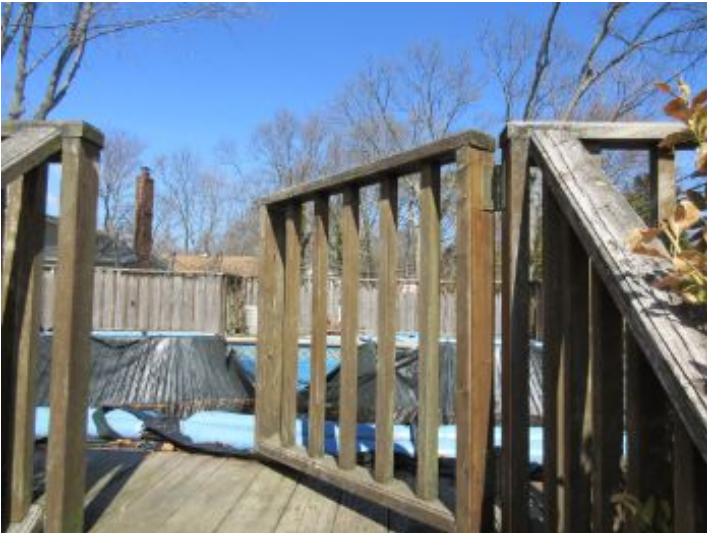
• The gate at the pool deck should be self closing and alarmed for safety reasons

Pool deck gate

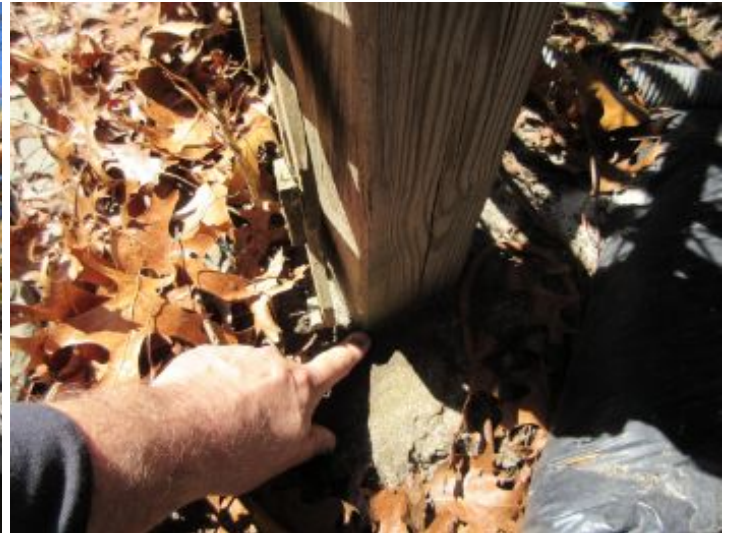
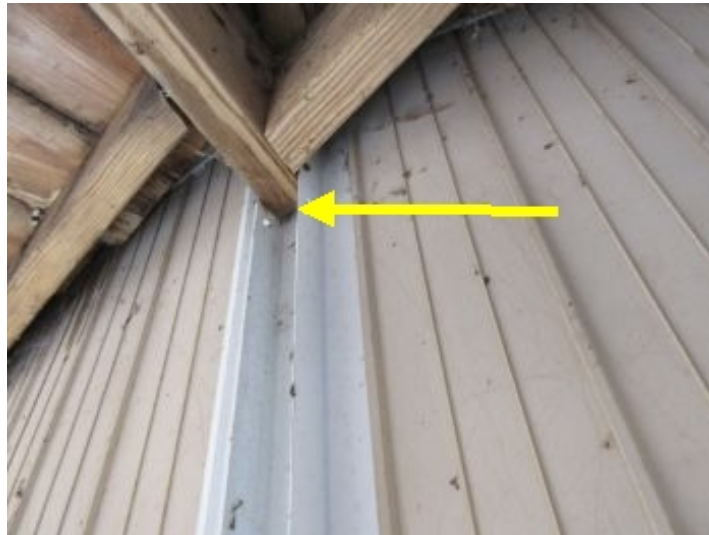
• The deck was relaying on the pool wall braces and pool edge for support. To avoid potential deck and pool collapse addition footing and deck posts should be installed for added deck support.

Post and footing

Addition support needed

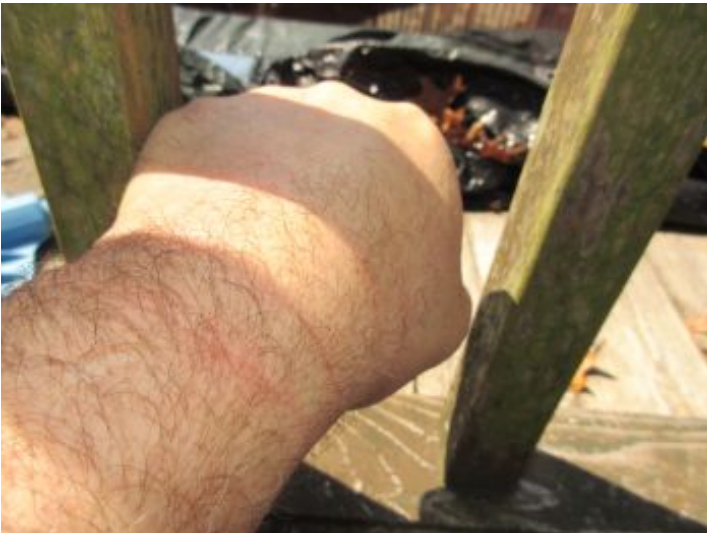
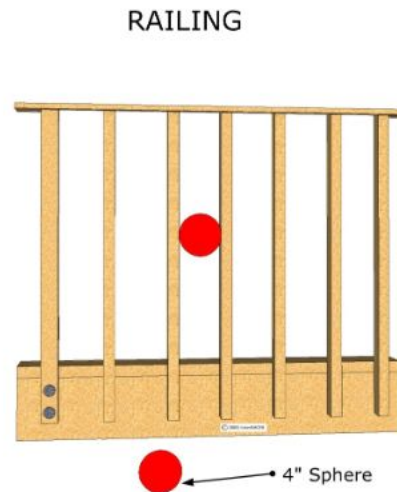
- The gate did not self latch or alarmed.

Pool balluster spacing

Balluster Spacing

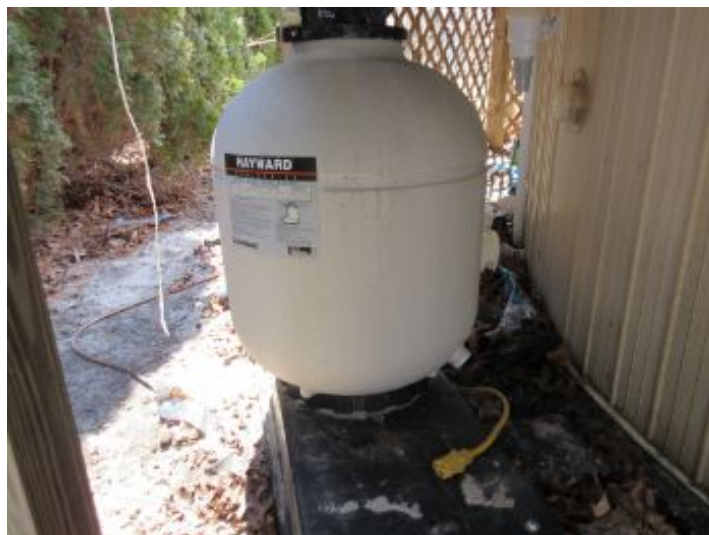
- The pool filter electric was supplied with Extention cords.
Recommendation: have a qualified licensed electrician install permanent **GFCI** protected electric supply to the pool filter.

Extention cord

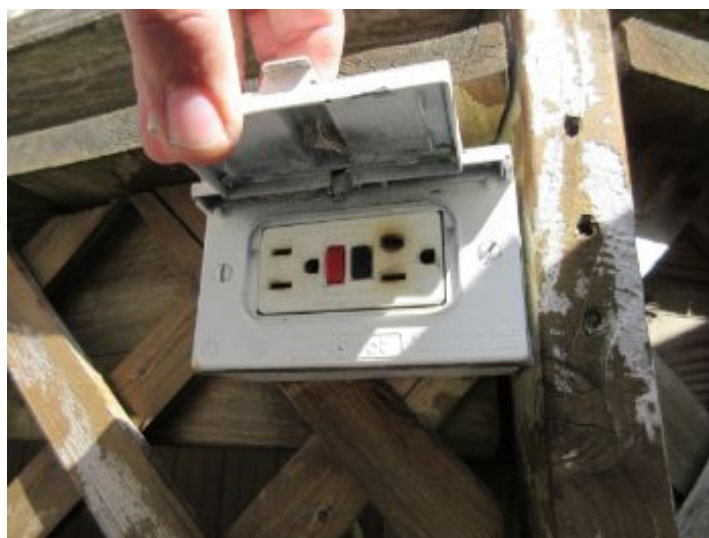
- The **GFCI** receptacle at the pool exhibited signs of a short circuit. This receptacle should be protected with an all weather cover to prevent electric shock hazard.

Damaged pool side GFCI
